Manhole Inspection Summary

Manhole # S09Y__003MH

Insp Date: **4/22/08 10:14 AM**

Location Address: **1251 S Grantley ST**

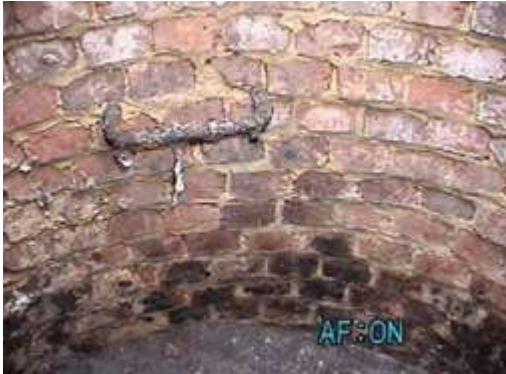
Defect 1

Count: **4** Missing: **0** ☒ **Corroded**

debris rusted rung

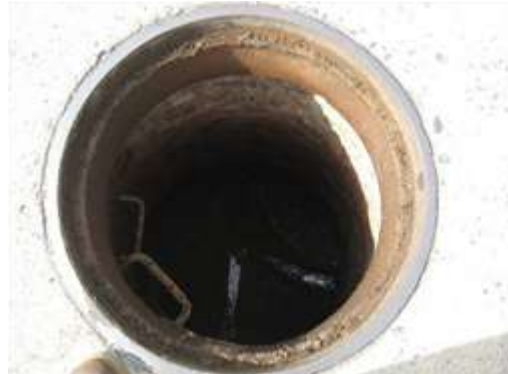
Defect 2

Condition: ☐ Sound ☐ Cracked ☒ **Leaks**

frame leaks

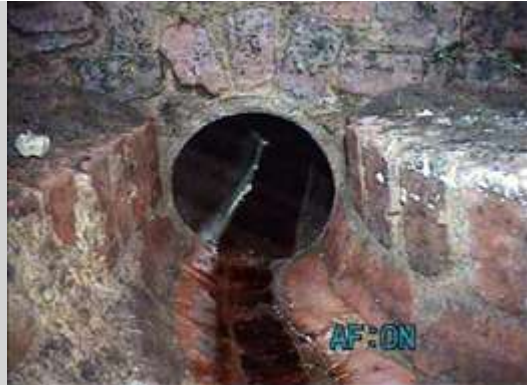
12 O'Clock Outflow

8 in. Circular Gravity Sewer
Pipe Out @ 12 O'Clock

Pipe Height: **8.4** (in.) Rod and Bar (Angled)
Pipe Material: **Clay** ☐ Pipe Lined
Invert Depth: **8.42** (ft.) Flow Characteristics: **None**
Deposits: ☒ None ☐ Mud ☐ Sludge ☐ Debris ☐ Grease
Silt Depth: **0** (in.) Deposits Extent:
Infiltration: **None** Pipe Seal Cond: **Sound**

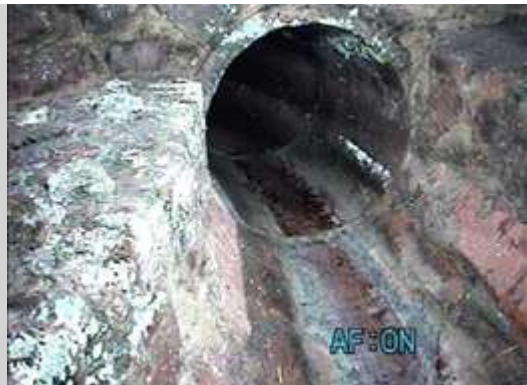
3 O'Clock Inflow

8 in. Circular Gravity Sewer
Pipe In @ 3 O'Clock

Pipe Height: **8.4** (in.) Rod and Bar (Angled)
Pipe Material: **Clay** ☐ Pipe Lined
Invert Depth: **7.81** (ft.) Flow Characteristics: **None**
Deposits: ☒ None ☐ Mud ☐ Sludge ☐ Debris ☐ Grease
Silt Depth: **0** (in.) Deposits Extent:
Infiltration: **None** Pipe Seal Cond: **Sound**

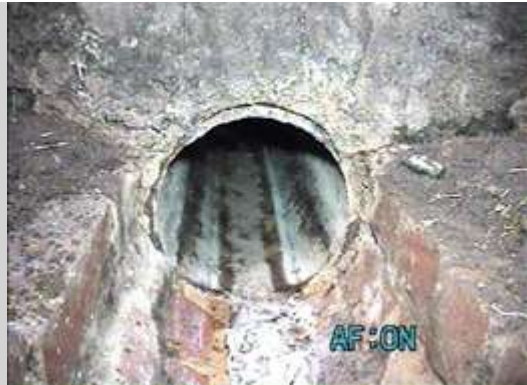
6 O'Clock Inflow

Infiltration: **None** Pipe Seal Cond: **Sound**
